2.0L XE Crank Seals

Front crank seal

Rear crank seal

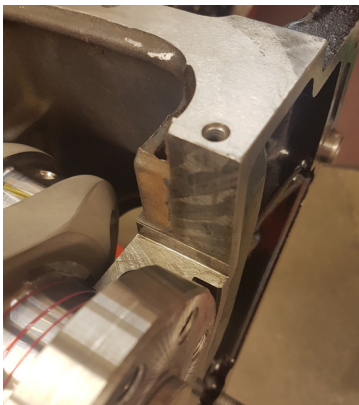
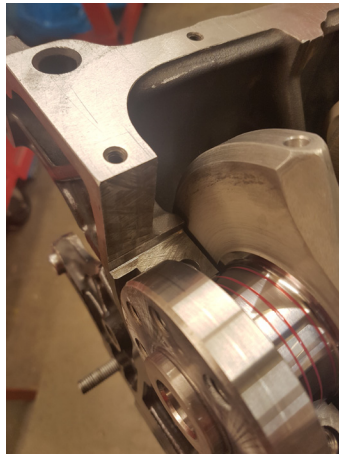
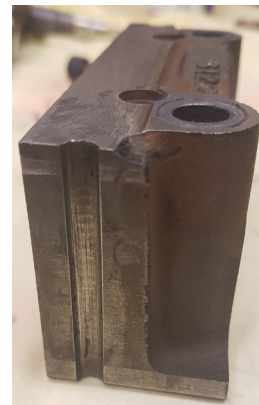
All faces must be fully cleaned and dried and have no residual silicon.
